Manhole Inspection Summary

Manhole # S19A__022MH

Insp Date: **10/24/07 1:07 PM**

Location Address: **801 LANVALE ST**

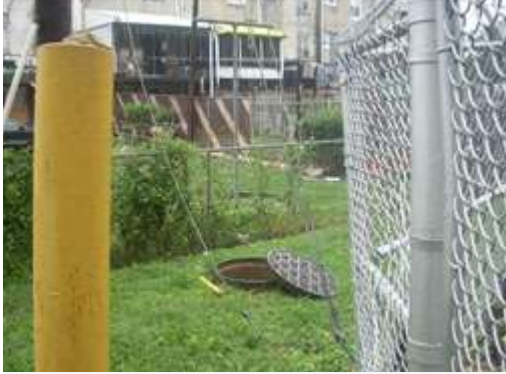
Location View

GRADE ADJUSTMENT

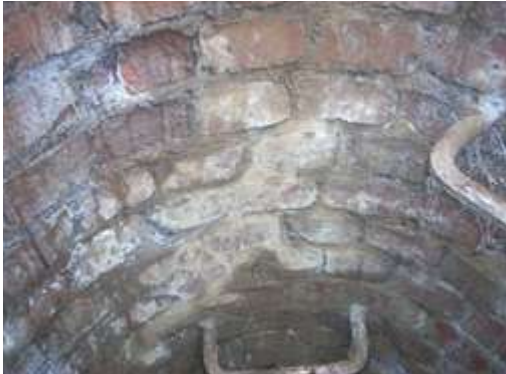
Defect 3

Infiltration: ☐ None ☐ Joint ☐ Cracks ☐ Mortar ☐ Roots ☒ **Wall**

INFILTRATION OF THE CORBEL WALL

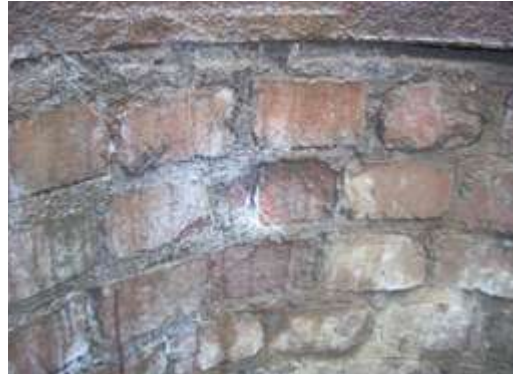
Defect 2

Condition: ☐ Sound ☐ Cracked ☐ Root Intrusion ☐ Loose Brick ☒ **Deteriorated**

DETERIORATED CORBEL

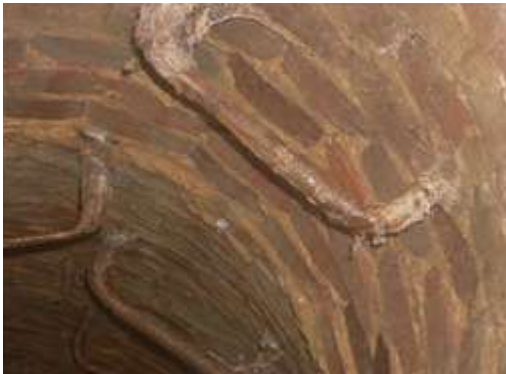
Defect 1

Count: **7** Missing: **1** ☒ **Corroded**

CORRODED AND MISSING STEPS

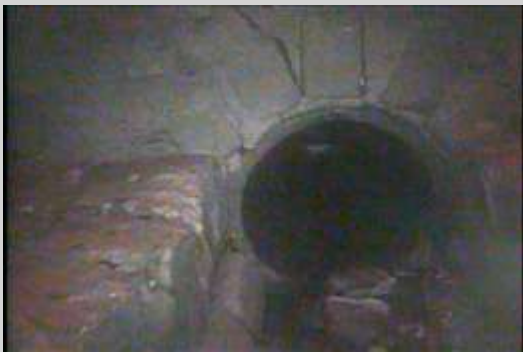
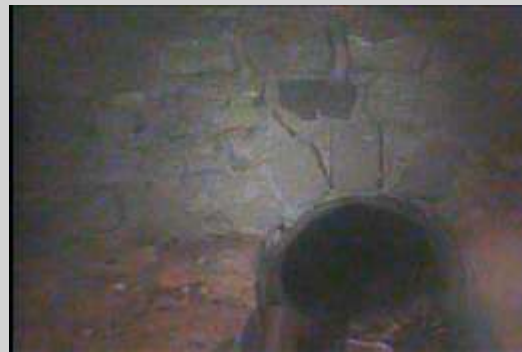
12 O'Clock Outflow

8 in. Circular Gravity Sewer
Pipe Out @ 12 O'Clock

Pipe Height: **8.4** (in.) Rod and Bar (Angled)
Pipe Material: **Clay** ☐ Pipe Lined
Invert Depth: **12.79** (ft.) Flow Characteristics: **Slow**
Deposits: ☒ None ☐ Mud ☐ Sludge ☐ Debris ☐ Grease
Silt Depth: (in.) Deposits Extent:
Infiltration: **None** Pipe Seal Cond: **Sound**

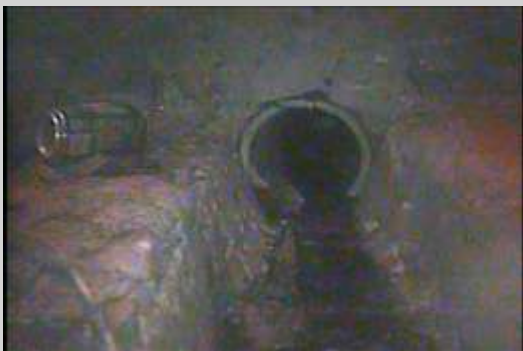
6 O'Clock Inflow

6 in. Circular Gravity Sewer
Pipe In @ 6 O'Clock

Pipe Height: **6** (in.) Rod and Bar (Angled)
Pipe Material: **Clay** ☐ Pipe Lined
Invert Depth: **12.59** (ft.) Flow Characteristics: **Slow**
Deposits: ☒ None ☐ Mud ☐ Sludge ☐ Debris ☐ Grease
Silt Depth: (in.) Deposits Extent:
Infiltration: **None** Pipe Seal Cond: **Broken**
